This Island Packet 29 suffered a wobbly stern tube

Stern tube concern

Mike Pickles on a routine boatyard job that became a serious reconstruction

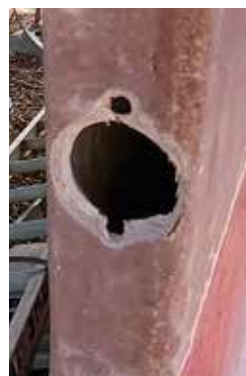
To my surprise, the tube was indeed wobbling about because it was held in place with just two bolts that were both threaded all the way and only secured with nyloc nuts and small washers. The GRP through which it was bolted was 12mm thick, however, where the nuts had been tightened they'd compressed the GRP to such an extent that the lower hole

GRP around the stern tube's lower bolt hole was compressed to such an extent that it failed

had compressed to nothing.

We agreed the following plan with the worried/relieved owner: clean out the keel, replace the shaft tube with a GRP one, build in a couple of supports between the engine and the aft end of the keel and reconstruct the exterior of the keel.

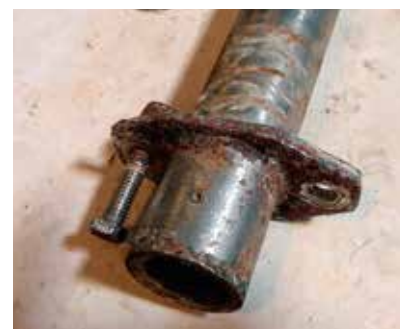
Stern tube withdrawn from the keel. A failed bolt hole in the keel GRP had allowed it to wobble

Furthermore there was no other internal support for the tube, even at the stern gland. Keep in mind that the 1in diameter shaft runs around 5ft between the skeg and the engine coupling. Having no internal support for the prop shaft tube or shaft is asking for trouble.

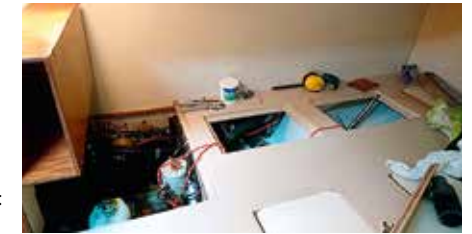
1 There were three hatches designed into the aft double berth: the forward, big inspection hatch is for the rear of the engine and gearbox coupling; the middle hatch allows access to the stern gland and greaser, while the aft hatch allows access to the aft of the keel and the exit of the propshaft tube.

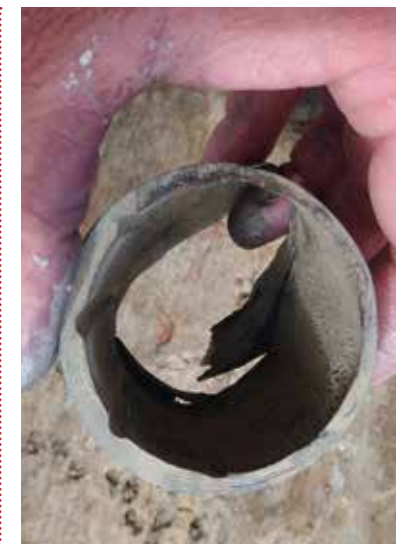
Here's a very worn cutless bearing: as you can see the shaft was clearly not aligned as wear to top is greater than anywhere else

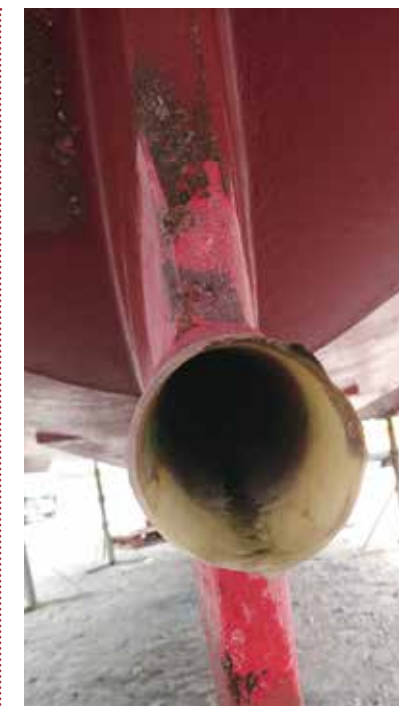
This very worn GRP stern tube is a combination of a serious misalignment and a poorly fitted shaft bearing that eventually allowed the bearing to spin!
